Manhole Inspection Summary

Manhole # S35A__006MH

Insp Date: **2/10/09 11:23 AM**

Location Address: **210 guilford av**

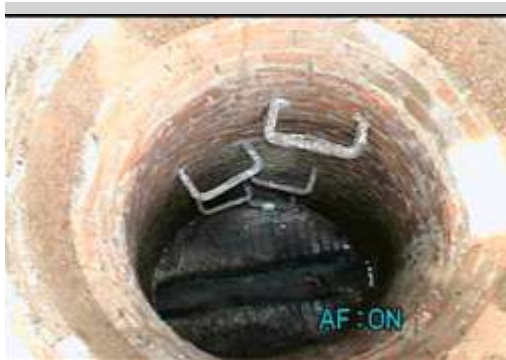
Defect 3

Steps Count: **5** Missing: **0** ☒ **Corroded**

corr steps

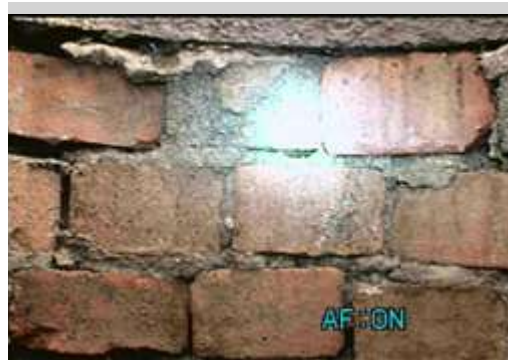
Defect 2

Condition: ☐ Sound ☐ Cracked ☐ Root Intrusion ☐ Loose Brick ☒ **Deteriorated**

deteriorated chimney, frame adj

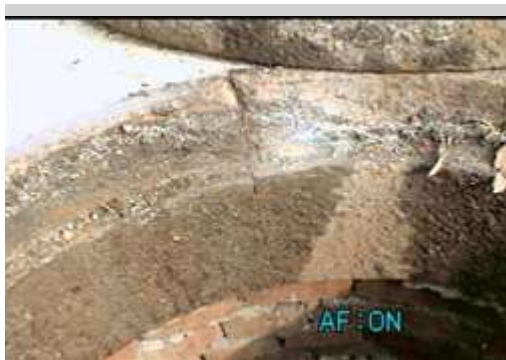
Defect 1

☒ **Cracked**

☒ **Leaks**

cracked frame, leaks

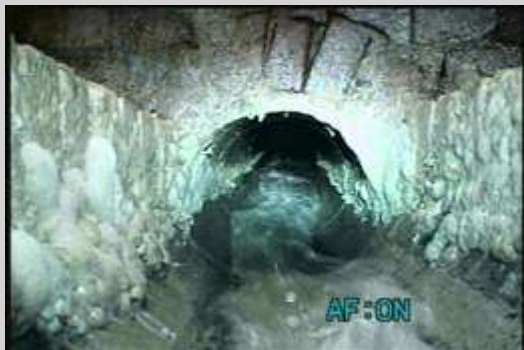
12 O'Clock Outflow

10 in. Circular Gravity Sewer
Pipe Out @ 12 O'Clock

Invert Depth: **10.41** (ft.) Flow Characteristics: **Fast**

Infiltration: **None** Pipe Seal Cond: **Unknown**

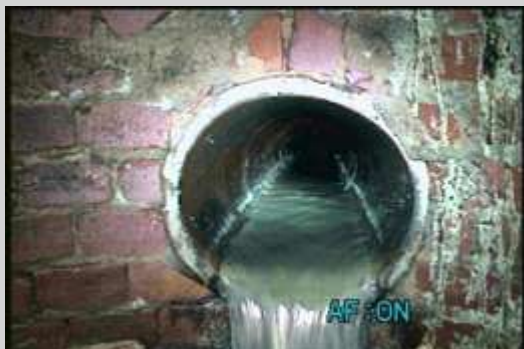
6 O'Clock Inflow

12 in. Circular Gravity Sewer
Pipe In @ 6 O'Clock

Invert Depth: **10.10** (ft.) Flow Characteristics: **Fast**

Infiltration: **None** Pipe Seal Cond: **Unknown**
